**AN ASSESSMENT OF LAND  
DEGRADATION IN THE HEADWATER  
CATCHMENT OF THE  
KLEIN ZEEKOEI RIVER,  
GREAT KAROO, SOUTH AFRICA.**

**Submitted in Fulfillment of the requirements for the Degree of  
MASTER OF SCIENCE**

**August 2000**

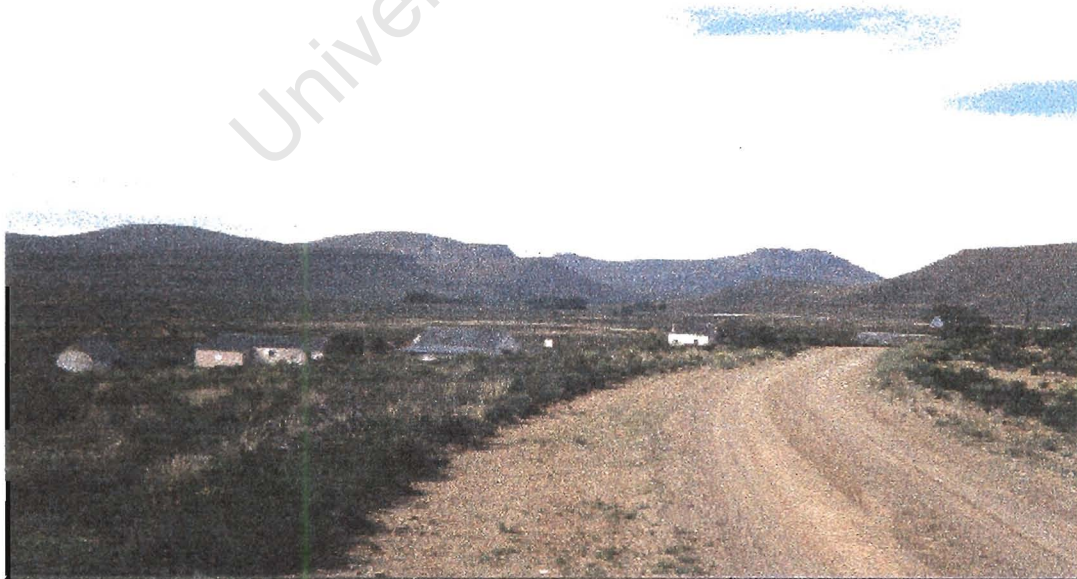
**Plate 1.1** Looking northwards down the Klein Zeekoei River Valley, note the Kriegersbaken farm buildings in the left foreground.

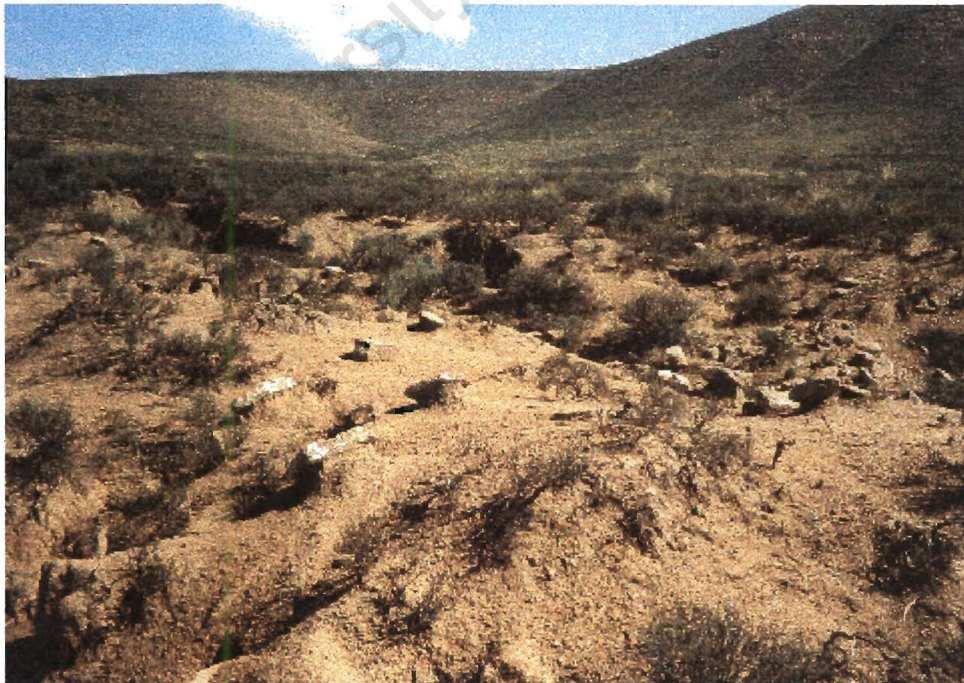
**Plate 5.1** Lucernvale site, showing badlands and pedestals capped with sandstone blocks. Note the scarcity of vegetation in the foreground (dominated by one species) compared to the undegraded slopes in the background.

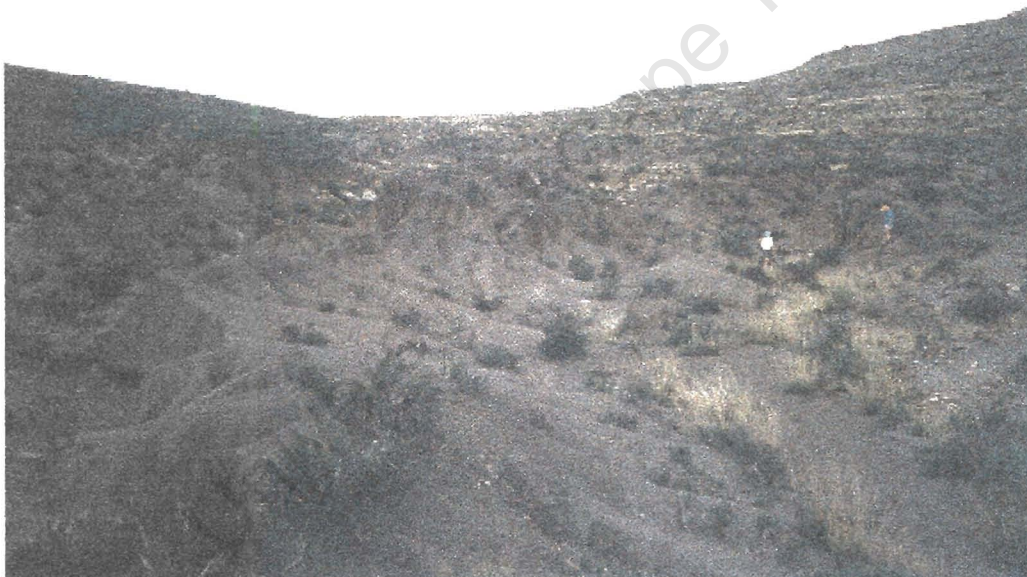
**Plate 5.2** The GHS site. Note extensive badland erosion in the foreground, and the figures for scale.

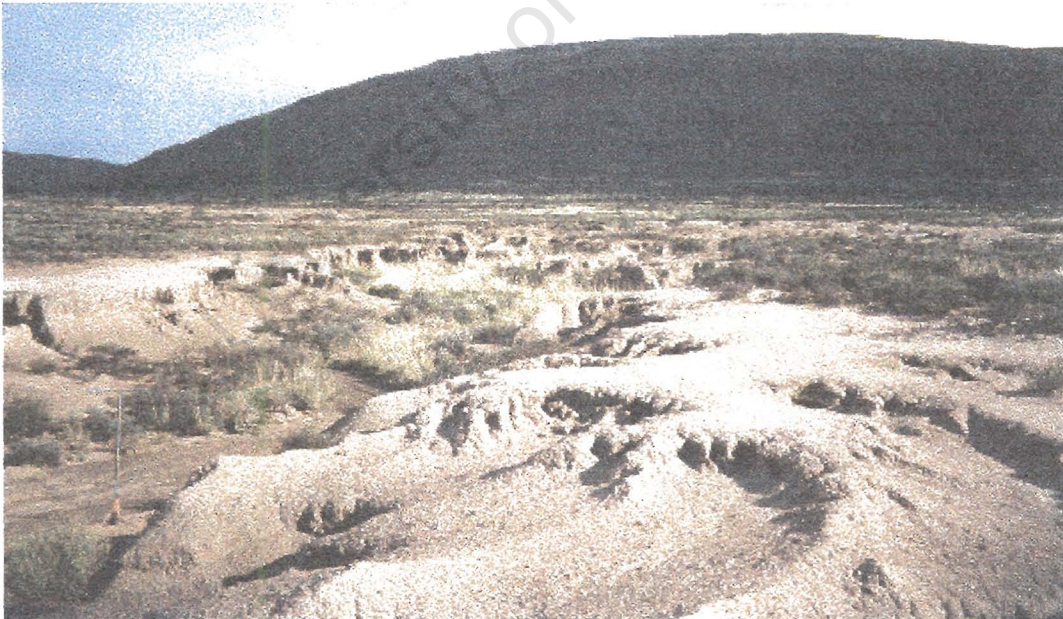
**Plate 5.4** The KBL site showing badland development and sheetwash. A soil auger in the left foreground gives an idea of scale. Note the absence of an A horizon, and the hard baked crust which occupies the A horizon position in the profile.

- KBL1: These samples were taken 50m west of the farm road leading to the Compassberg homestead. There are two distinct horizons in this area; an A horizon which is mostly stripped, and where it does occur is not more than 10cm deep. The B horizon appears to be desiccated and impermeable.
- KBL2: These samples were taken 250m west of the farm road leading to the Compassberg homestead. Erosion to the shale bedrock has occurred in some gullies at this site. The maximum depth to bedrock is 1m. There appears to be a B and C horizon at this site, denoted by a slight color change, and possible evidence of the B horizon being more resistant. Some piping occurs in this area, and the B horizon forms the roofs of the pipes.

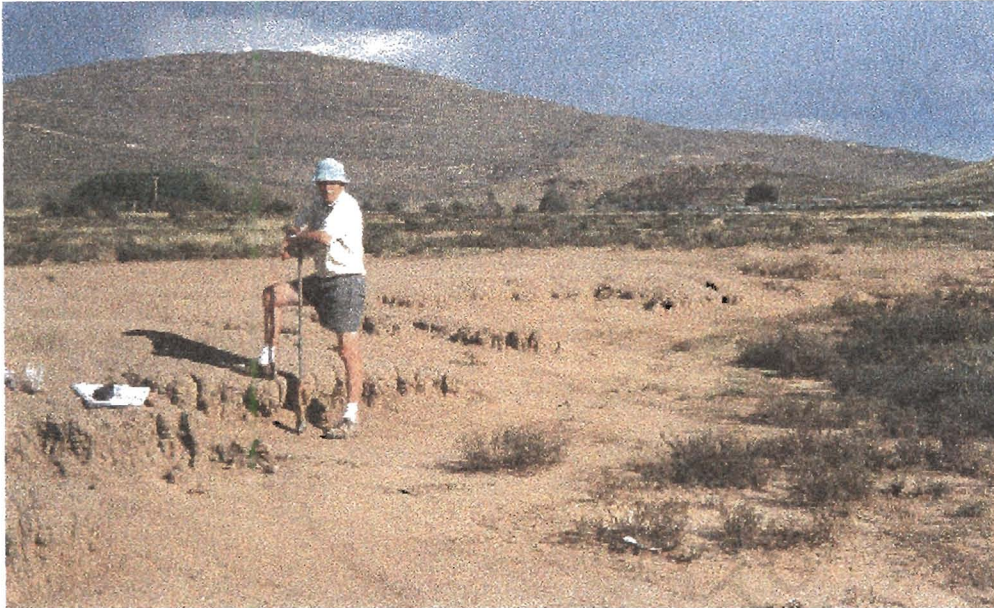
**Plate 5.5** The KBL site, showing extensive sheetwash. Note once again, the absence of an A horizon, and the hard baked crust which occupies its position in the profile.

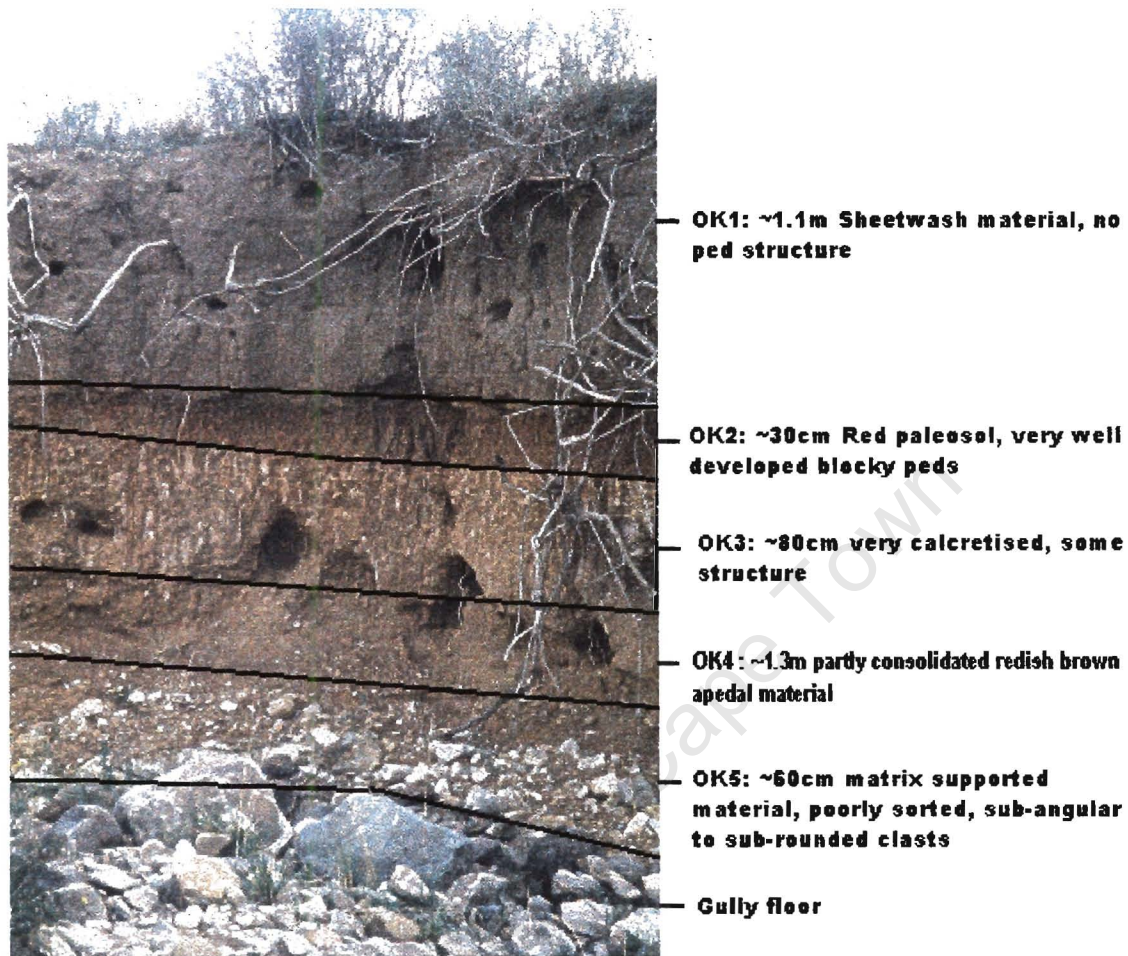
**Fig 5.4** Oppermanskraal gully profile. Total gully depth is 4.1m. The holes / burrows are presumably of biogenic origin.

The Oppermanskraal site is situated on the farm Good Hope approximately 1Km north of the Oppermanskraal farmstead (Fig 5.1). This site is part of a valley floor gully running in a west - east direction on a gentle west facing slope and having a total length in excess of 3Km. At the sampled section the gully was 4.1m deep and consisted of five distinct stratigraphic units (Fig 5.4). This was the only site that displayed a marked amount of calcification in some of the stratigraphic units (OK3 and OK5). It was noticed that the clast material in OK5 is very weathered, and the doleritic material is exfoliated. The clastic material is composed of approximately 5% dolerite, 20% shale and 75% sandstone, and does show some imbrication. Unit OK5 overlies the shale bedrock which is exposed in the gully floor.

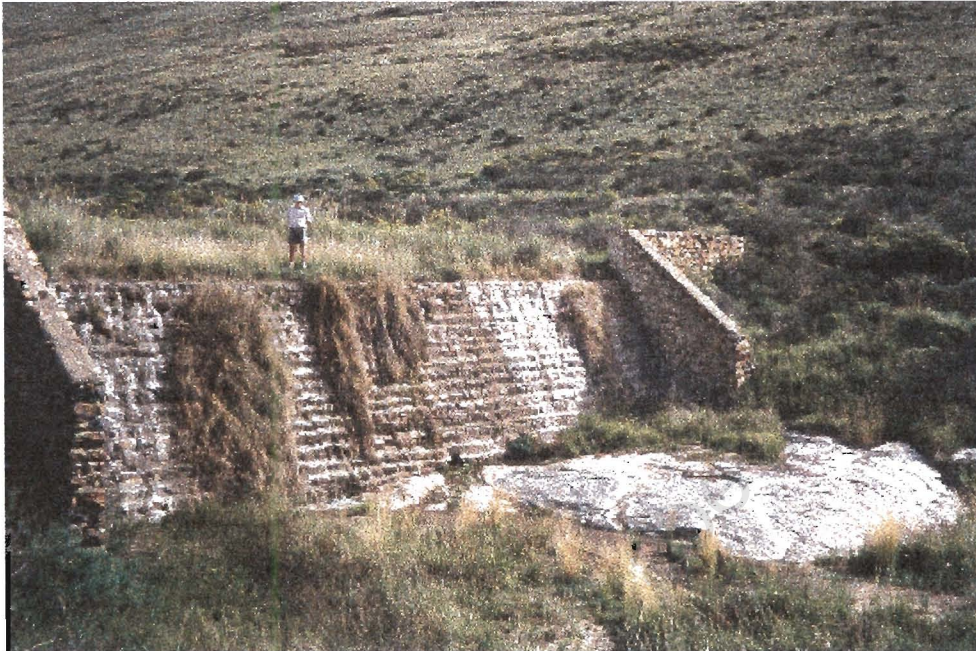
**Plate 5.6** The uppermost weir in the Klein Zeekoei River Valley.

There are four anti erosion weirs constructed in the main water course that runs through the Klein Zeekoei River Valley (Fig 5.1). Aerial photography and personal communication with the farmer (H.N. Sheard, pers comm) indicate that these weirs filled with sediment within ten years of their construction in the late 1940's and early 1950's. Hand coring with a gouge auger was attempted at the uppermost, (most southerly) weir (Plate 5.6). Shale bedrock occurs at a depth of 2.9m. Coring was only possible to a depth of 57cm, where clastic material was struck. No significant stratigraphy was observed in the top 57cm.

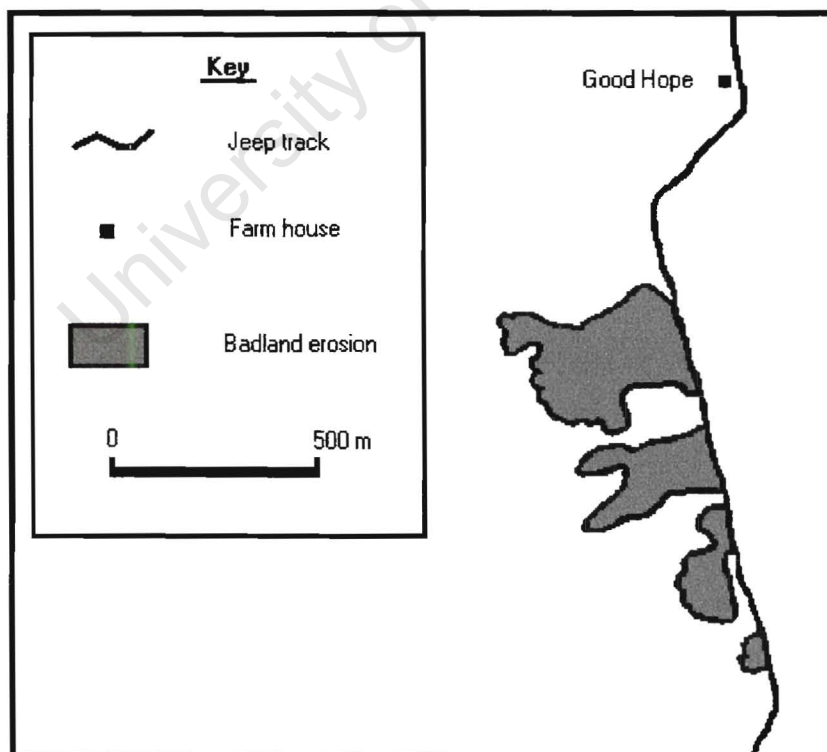
Fig 6.7 Extent of badland erosion at GHS, 1945.

This area of badland erosion situated on a footslope approximately 800m south of the Good Hope homestead has increased in spatial extent by approximately 10% between 1945 and 1980 (Fig 6.7 and Fig 6.8). A comparison of the 1945 and 1980 land degradation maps (Fig 6.16 Fig 6.17) reveal that the severity of the erosion is largely unchanged over this period.

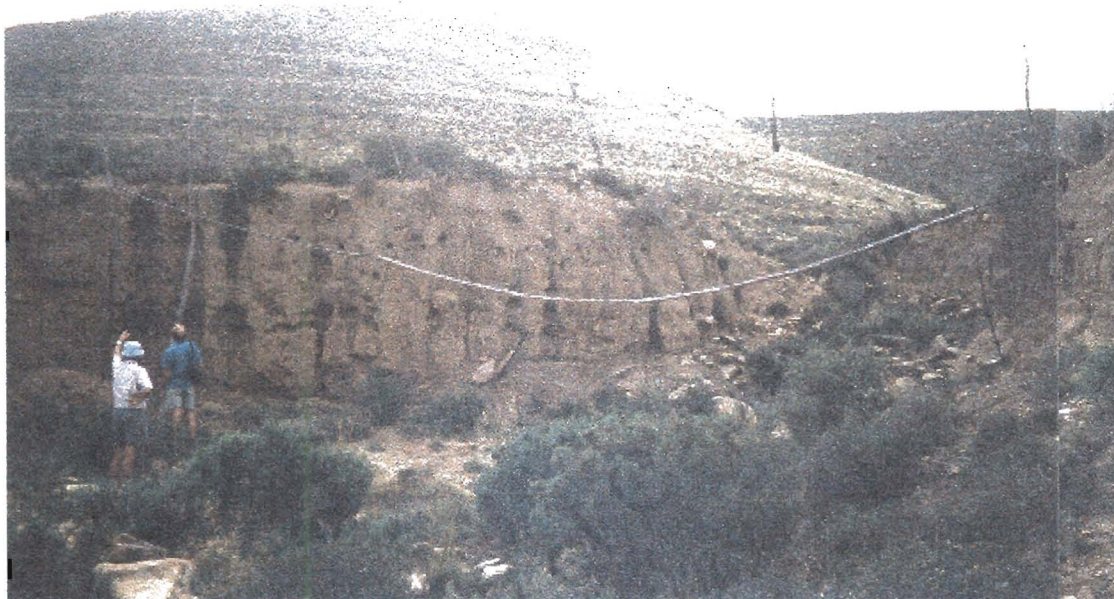
**Plate 6.1** Hanging fence gully. The gully depth at this point is 4.05m and the width is 15.1m. Note the two extremely long fence posts on the extreme left.

Field measurements were taken, in order to calculate the volume of material that has eroded from the gully, since incision occurred. This calculation yields a volume of approximately 11 500m<sup>3</sup> of sediment, which has been lost over a period not longer than 40 years, and from a catchment that is only approximately 1km<sup>2</sup> in area.

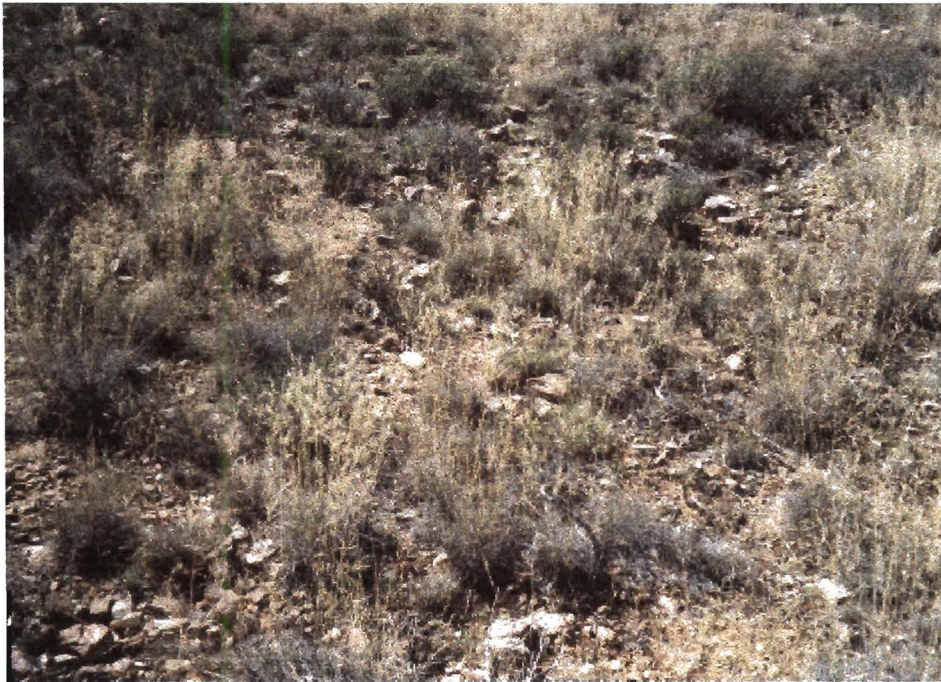
**Plate 7.1** Stage 1 in the model of badland development. Note that the ground cover offered by vegetation and stones is high, leaving very little bare ground exposed. Note the presence of grass.

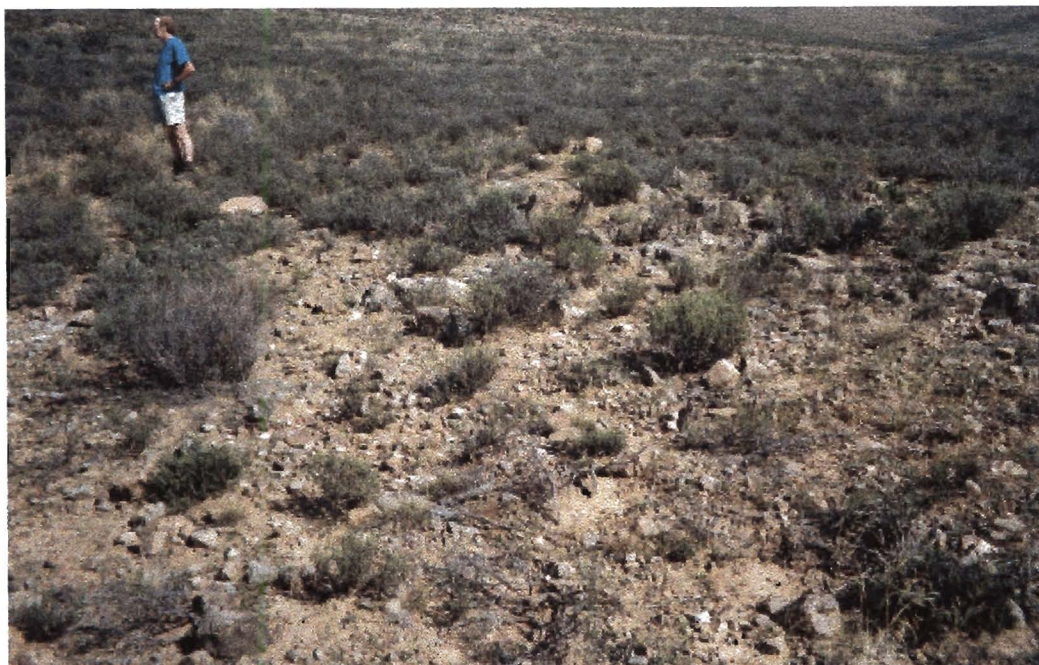
**Plate 7.2** Stage 2 in the badland development model. Stage two occurs in the foreground of this photograph. Note the marked increase in bare ground compared to stage 1. Note also the figure for scale, the relative absence of grass and the relatively un-degraded slopes (stage 1) in the background.

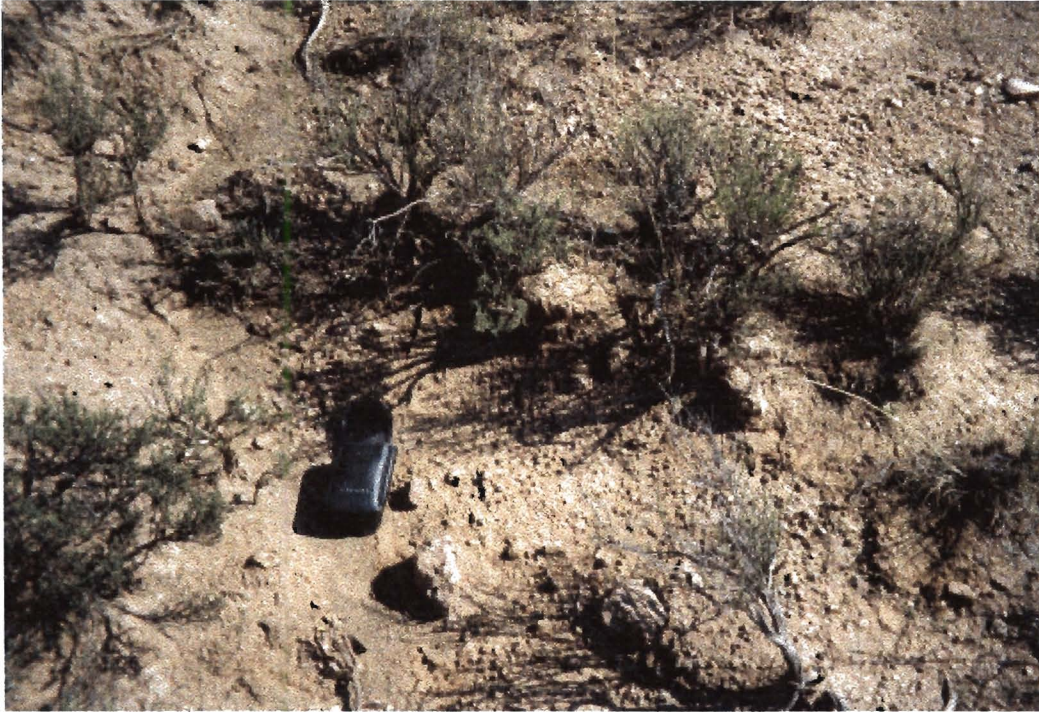
**Plate 7.3** Stage 3 in the badland development model. Note the camera case for scale. Also note the reduction in small stone cover, the humps around the vegetation, the single species of shrub, and the rill that the camera case is lying in.

In stage 3, the most significant change is that there is evidence of water flow in the form of rills, and humps around vegetation. Due to the loss of unconsolidated material, slopes start to evolve. The vegetation cover is still approximately 20% (90% scrub, 10% grass), however the small stone cover is lost. Wide, flat, partially stripped interfluvies develop. Plate 7.3 shows a close up view of an area that is in stage 3 of the badland development model.

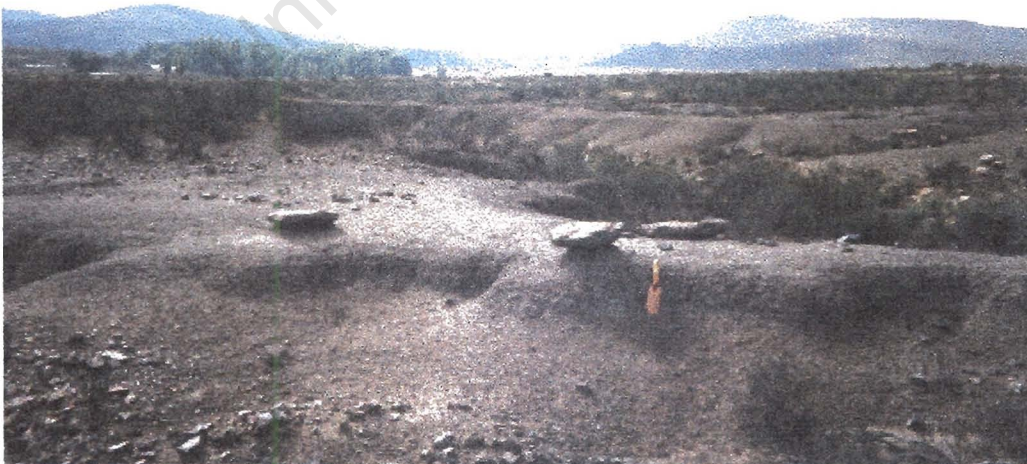
**Plate 7.4** Stage 4 and Stage 5 in the badland development model, note the trowel in the foreground for scale. Stage 4 is in the foreground, where pedestals occur on otherwise stripped interfluvies. In Stage 5 (in the background), the pedestals have been eroded away.

In stage 5, as with stage 4, there are active gully systems, and vegetation cover is less than 10%, with a single dominant shrub species. In stage 5 however, the pedestals have disappeared (eroded away), and the landscape comprises mainly slopes, with sandstone blocks occurring mainly in the gullies, where they have been deposited by a combination of slope and fluvial action. There is evidence of high runoff, and rills are active on very small areas of catchment (An area of 2-3 square meters is able to sustain active rills). There is evidence of grasses growing in a few centimeters of unconsolidated fines within the channels (gully floors). Plate 7.5 shows a view of badland erosion with stage 4 in the foreground (still displaying pedestals) and stage 5 in the background, where the pedestals have been eroded away.

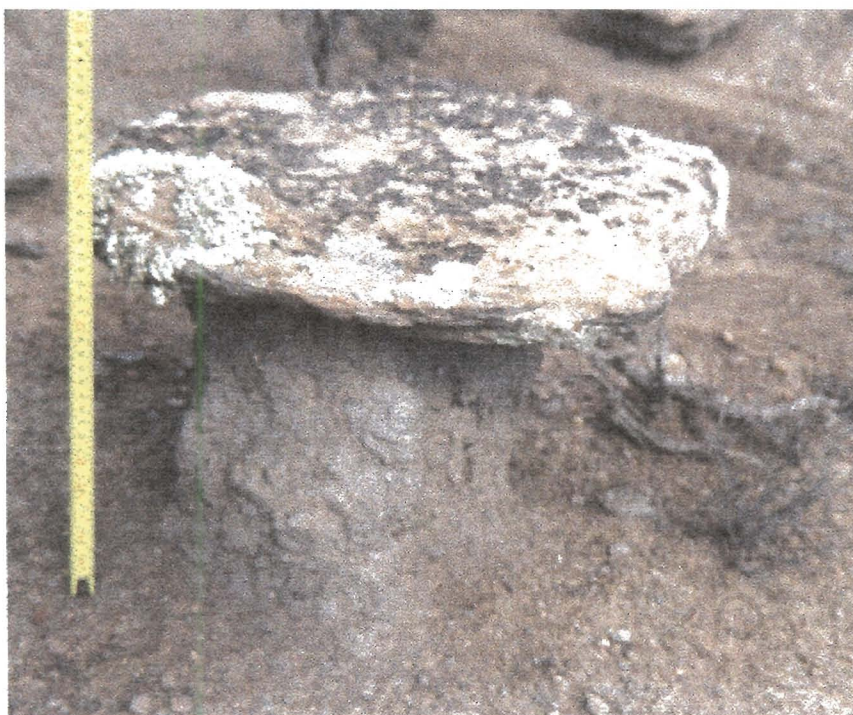
**Plate 7.5** A pedestal typical of the type found in stage 4 of the badland development model. This particular example is approximately 25 cm high. Note the lichen on the sandstone block.
